TREBIANO CASTLE ARCOLA (SP) ITALY

The proposed project deals with the recovery of the castle of Trebiano hamlet of the municipality of Arcola (SP). Trebiano is a small village, of Roman origins, of the valley of Magra in a dominant position compared to the surrounding countries. The Magra Valley is a unique example of ancient territorial architecture; the settlements are arranged in such a way that they can defend each other. Each village is able to cross at least two other settlements, thus creating a defensive lattice that put in a position to defend against any invaders.

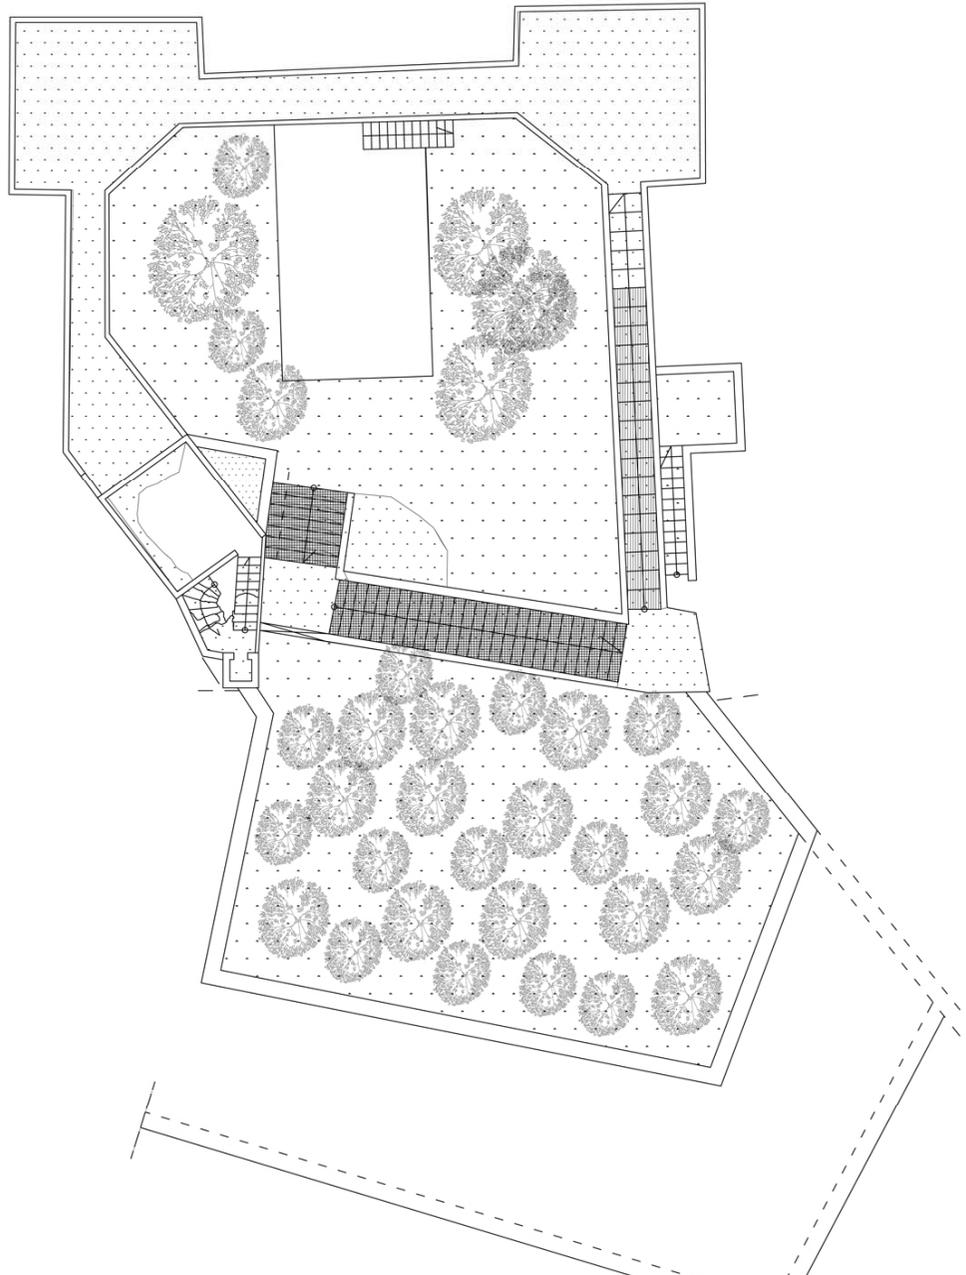
Pianta scala 1-1000

The phase: the plantThe analysis is started by the plant that shows how strong the presence of upper and lower vegetation (weeds) that make even unattainable parts of the factory: the east wing, part of the outer walls and the exterior of tower three. The cause of this large presence can be attributed to two factors: one, as mentioned above, may be the abandonment of the structure the other is intrinsic in the design, in fact inside the courtyard was and still is present an embankment, which had the function of making the base more resistant to external assaults but which in this case has turned into a fertile ground. The first ramp, made with marble tread, has in addition to the usual infestation lower vegetation, a biological patina on the handrail, on the marble stone is evident a patch of brown color. On the second ramp can be found, in addition to the strong presence of weeds, the lack of much of the pavement to rise. On the rest of the promenade there are traces of lower vegetation (weeds) and the missing part of the parapet.

The second phase: the prospectuses On the east elevation is visible, on the dial of the rampant arches and on the initial part of the parapet, the lack of much of the plastering the erosion of the remaining part of plaster, most likely caused by a set of water and wind; there are also some brown spots and lower and climbing vegetation. Inside the two times show many efflorescences and the presence of a biological patina. On the south elevation there is, on the parapet, the lack of plaster and the presence of lower vegetation; on the dial of the rampant arches the plaster is eroded with the presence, on two areas of a biological patina. The buffers of the arches appear to be healthy with only a few climbers; on the stone base of the arches there are a number of areas attacked by biological patina, saline efflorescence and some climbing. Two pillars that support the leftmost arc are partially broken, although they do not appear to compromise the stability of the structure above. The west prospectus does not show remains of plaster, so it is not conceivable that it is a past presence, although much of the top is covered by the vines. We find a demolition of the upper part of the plinth but most likely passed and not due to a pathology; there is also the presence of a saline efflorescence on the lower left. The north elevation has at the top the lack of the plaster that ran through the entire parapet and the dial of the right arch; on the dial and on the reintroduction of the left arch there is part of the plaster, which, however, is eroded. Below the left arch there is a climbing infestation, as well as on the plinth. The attack between the arch and the tower is noticed a crack, probably caused by the non-contemporary realization.

Phase III: the two towersI inner prospectus of the south tower are quite degraded but all in good condition; Prospectus 1 shows that the main ailments are the lack of mortar in the joints at both the top and the bottom, the strong presence of concretions at the top that run from the vault; there are some manifestations of lower vegetation. Prospect 2 always shows a strong presence of concretions on the top, in a lower tone at the bottom and some brown spots; you notice a creeper and some manifestations of lower vegetation. Prospectus 3 shows strong signs of no mortar in the joints and a large brown spot. In addition to the large lack of mortar in the joints, there is a rather large area of saline concretion at the top. The vault that concludes the tower is severely degraded by biological patinas and saline concretions that have led to the formation of stalactati; this is caused by the passage of water inside the joints, a symptom of the presence of cracks inside.

The first conservation operation is the mechanical culling of primary vegetation, both in the main court and in the south wing and in the immediate vicinity. Mechanical and chemical elimination of secondary vegetation; this operation is carried out on the elevations or on the wall surfaces, since a mis-implementation of the methodology (which will be illustrated below) could lead to even serious failures.

On the perimeter masonry, a first mechanical mowing is carried out, being careful not to remove the roots, so by spraying the biocide is applied, which will dry the roots and make it safer to remove them even if a certain caution is always needed; Finally, the masonry is compensated, which the shrub may have compromised, with mortar or with the insertion of new stone elements, if necessary. We then move on to the application of biocides by using a brush for the elimination of the biological patina, the compensation of the mortar missed in some joints to the insertion of mortar for the sewing of some lesions, and the consolidation of some parts of the parapet that turn out to be patchy, the consolidation of the parts still present of finishing plaster and the drafting of a layer of lime water on the masonry where there are still traces of plaster. Several stainless steel chains placed on the kidneys of the arches are inserted on the perimeter masonry at the arches. The towers must be treated, at the same time, to eliminate the saline concretions present and stains due to air pollution, a micro blasting type of THE JOS type is used. As a result of the first cleaning, the mortar joints are restored and the stone elements present in the end are made structural chains of reinforcement in stainless steel. The parts of badly compromised walls will be dismantled and reassembled; proper foundations are carried out and then, the walls are rebuilt by reusing the existing stone material in the apartment it is necessary to replace the two forged iron chains, which, due to the weather, turn out to be worn out and the replacement of some marble steps, which turn out to be fractured and missed by some parts; while it is necessary to consolidate with mortar and stone elements both the decoration and the parapet also of the apartment. Existing railings are restored with railings up to 1 metre to ensure their safety to the public

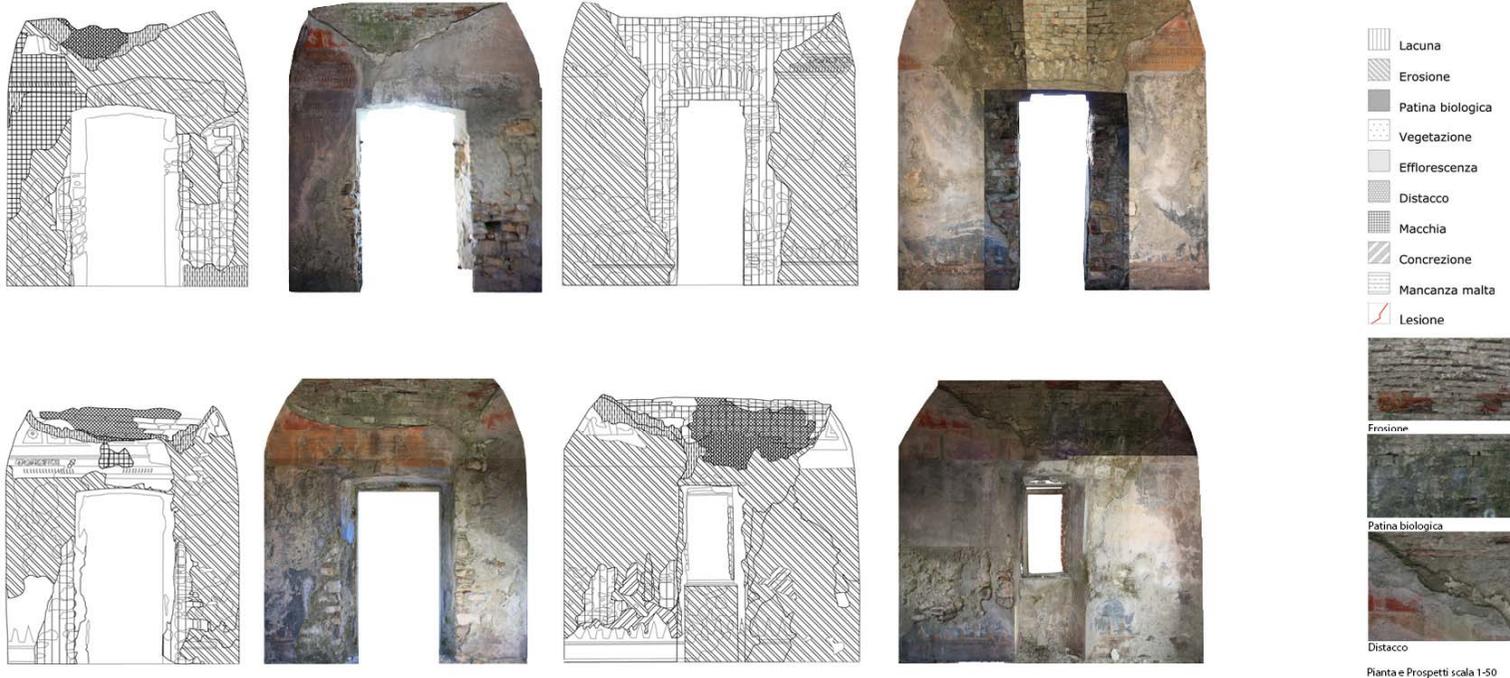
Pianta e Prospetti scala 1-50

The vault is of particular interest; as it is visible in the plant does not have a classic trend but turns out to be trapezoidal in shape, this system has allowed to get a wide entrance to the apartment. There is also the presence of a low sixth arch that had the function of supporting part of the parapet now almost completely lost. The reindeer and the parapet are uneven masonry with discontinuous weaving (made of mixed masonry natural-artificial stone), we find on some of them traces of plaster. The two towers have similar structural characteristics, the masonry weaving turns out to be continuous and homogeneous in semi-worked stone, on all four elevations inside are found false-turn slits also made of semi-worked stone. There is also the presence of a hole coinciding with the top of the vertical masonry of the prospectus next to it. The roof is formed by a large barrel vault cut at the opening, which makes it trapezoidal in shape, on which a full-sixth exhaust arc is placed which distributes the pressures on the vertical masonry; both structures are in split natural stone. Above, we find two small rampant arches in uneven masonry, which act as a link between the side walkways and the masonry of the vertical of the towers; we also find a low sixth arch that has the function of supporting the parapet.

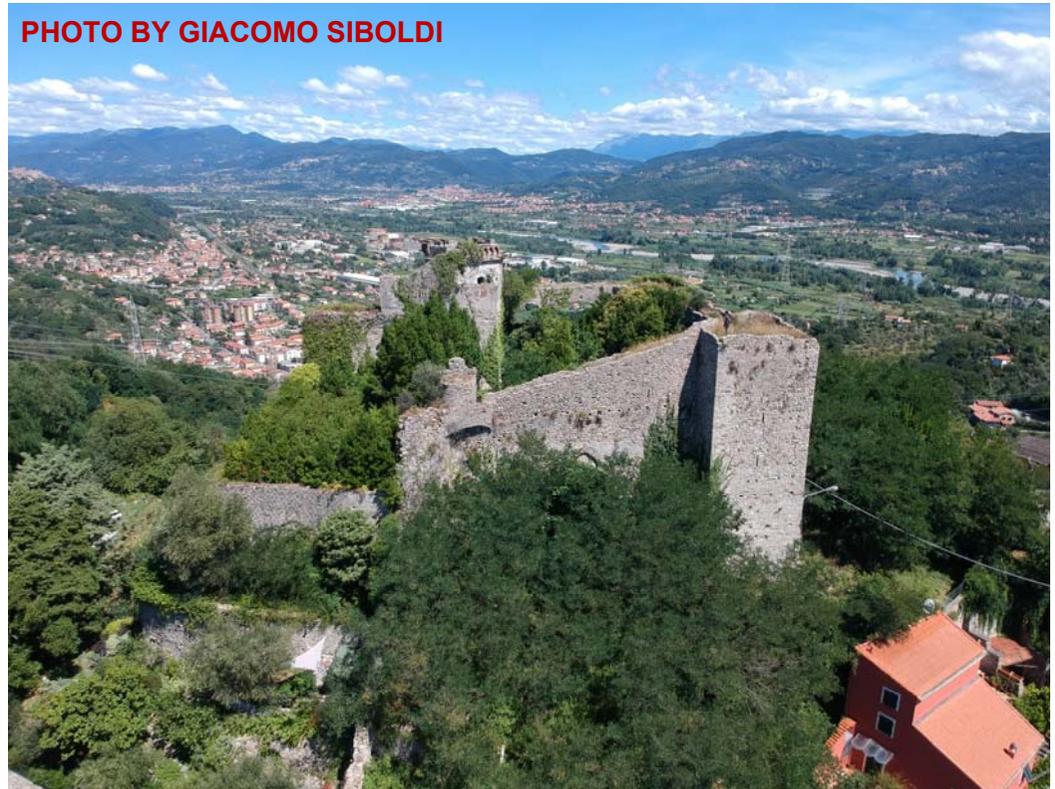
Failure refers to the series of problems always related to alterations in the static structural balances of the construction model. Visible manifestations of failure can have a very complex nature and the most varied intensity, but they are always attributable to cracks or deformation. Degradation and failure appear to be visible manifestations of the causes of alteration, they can coexist, manifest partially, be the cause of each other, but they must always be read in a clear and distinct way. The causes of degradation can be divided into two chapters: extrinsic or intrinsic; The intrinsic causes are contemporary at the birth of the building and can be caused: by the positioning, the stratigraphic conformation of the boulder, the geographical and environmental location, or by the type of the geomorphological topographical site.

Or they can be related to the structure and depend on the lack of composition of the individual materials (poor quality or lack of reliability), lack of execution (construction errors) or design errors (incorrect choice of the base boulder, etc.). The extrinsic causes are attributable to long-acting natural agents, they can be of a physical nature (thermal, water, salts, geological), chemical in nature (oxidation, alterations, air pollution, electrochemical decomposition of salts in water), or be due to biological or microbiological agents (plant, shellfish, parasites, microorganisms, guano). They can also be related to occasional natural agents, such as earthquakes, landslides or floods. But they can also depend on the work of man (wrong use, overload, air pollution or wars). The analysis of the degradation was carried out: on the plant, on the four internal elevations, on the interior of the two towers and the apartment. The structure is severely degraded due to abandonment, this has allowed the proliferation of weeds: prunes, climbing plants and trees with very wide canopy. This fact, however, at the moment, does not seem to have affected the masonry weaving that, except for a few areas, is well preserved and healthy in appearance.
